Manhole Inspection Summary

Manhole # S17I__024MH

Insp Date: **8/3/09 8:53 AM**

Location Address: **2301 CALVERTON ROAD**

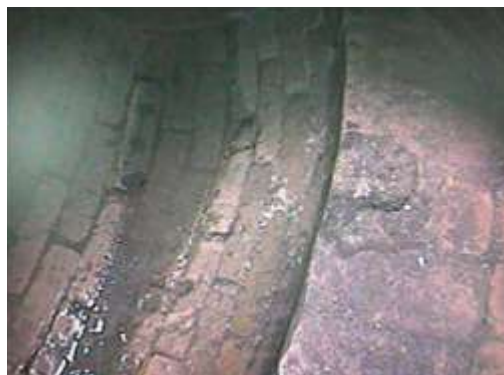
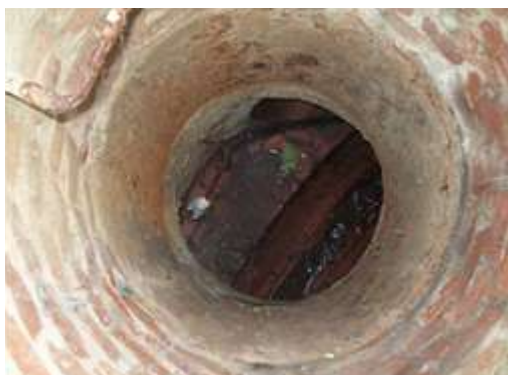
Top View

Comments **WENT TO LOCATION TO RETAKE TOP VIEW PHOTO - ASUR ADDED PHOTO. 4-22-09**

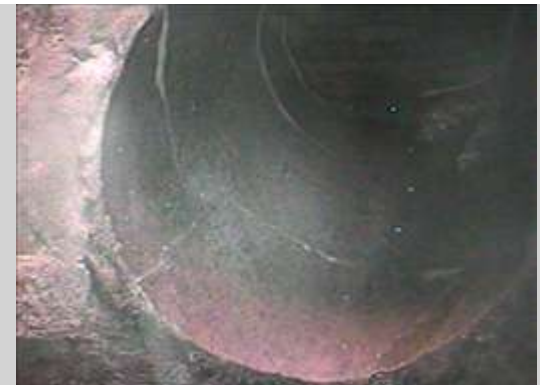
5 O'Clock Inflow

8 in. Circular Gravity Sewer
Pipe In @ 5 O'Clock

Pipe Height: **8.4** (in.) Rod and Bar (Angled)
Pipe Material: **Clay** ☐ Pipe Lined
Invert Depth: **14.16** (ft.) Flow Characteristics: **None**
Deposits: ☒ None ☐ Mud ☐ Sludge ☐ **Debris** ☐ Grease
Silt Depth: (in.) Deposits Extent:
Infiltration: **None** Pipe Seal Cond: **Sound**
